uhab | urban
homesteading
assistance
board

milbank building portfolio needs assessment report

2010 september 21

**Milbank Housing
Portfolio**

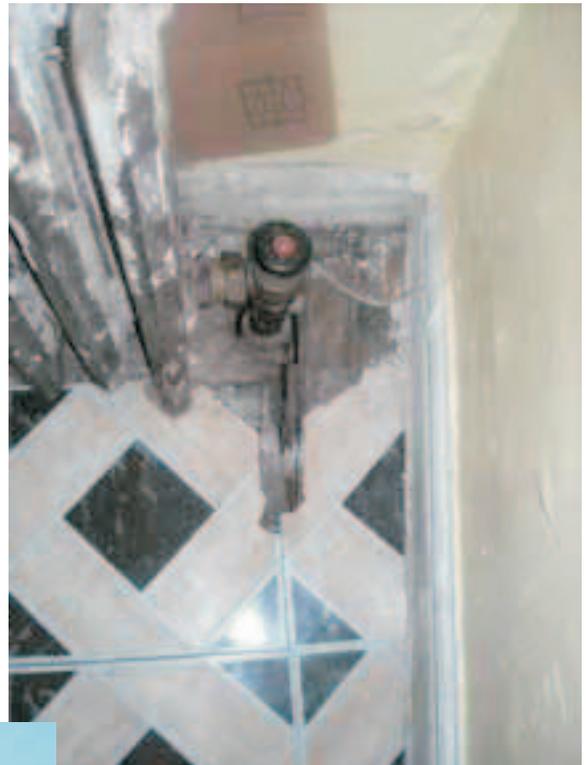
Typical radiator/floor damage

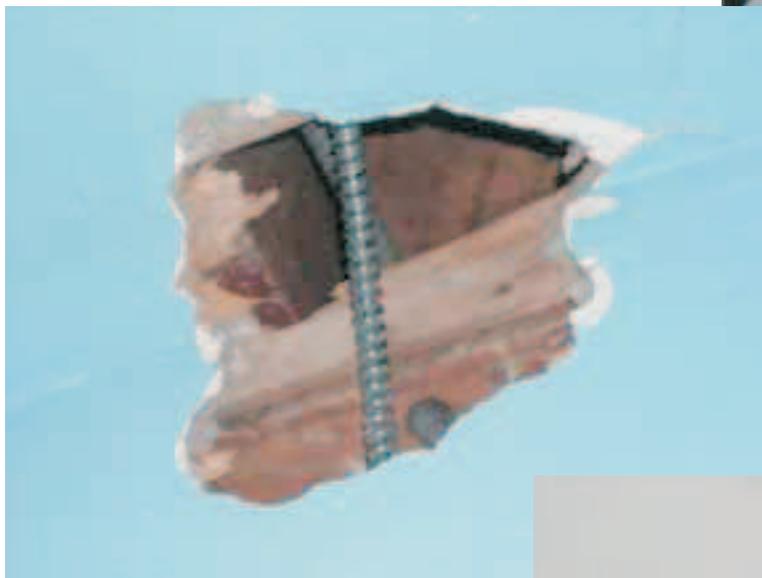
Exposed wiring in bathroom

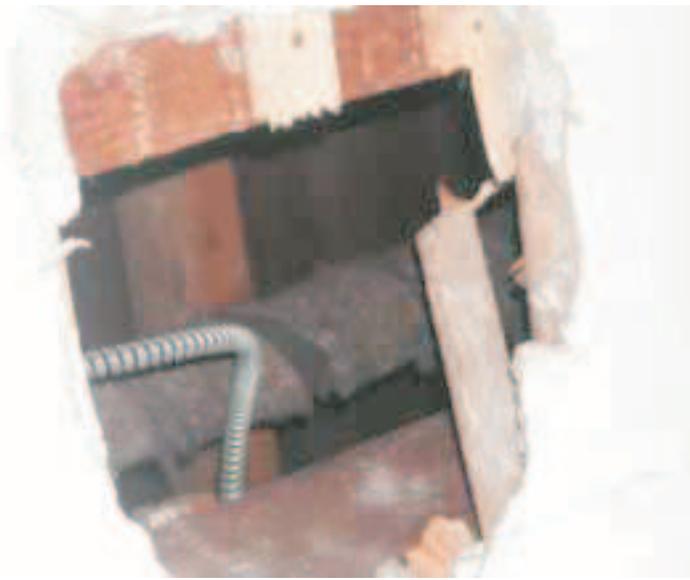
Exposed electrical and plumbing in bathroom

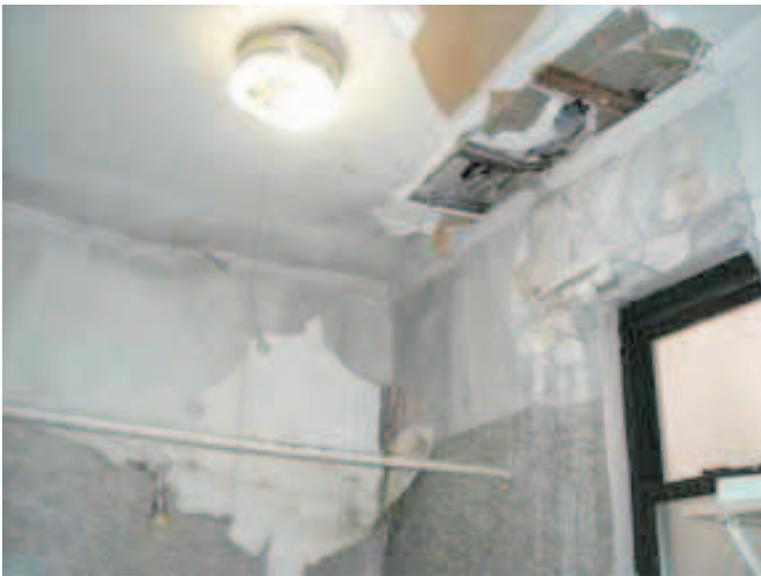
Bathroom with severe mold

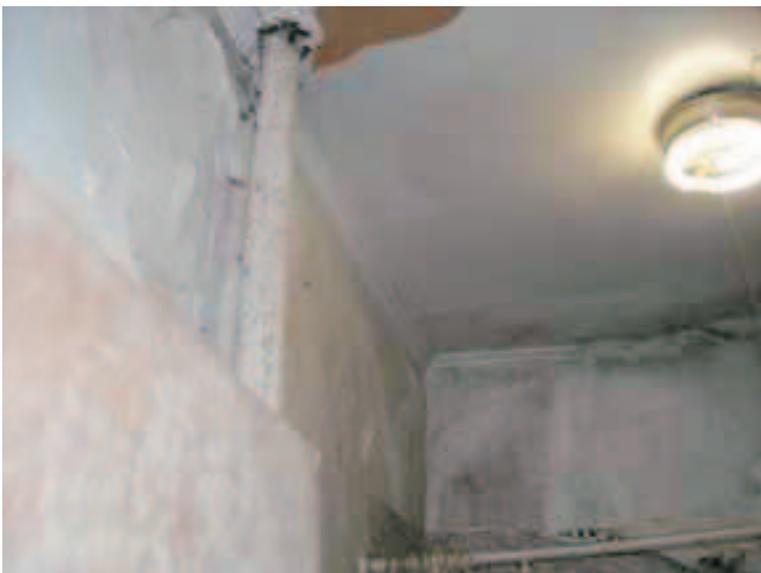
Bathroom with severe mold

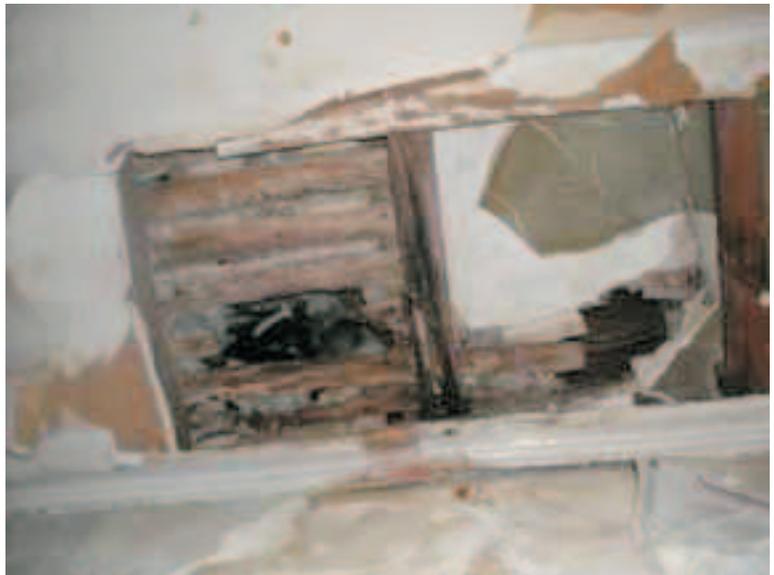
Damaged living room ceiling from
water infiltration

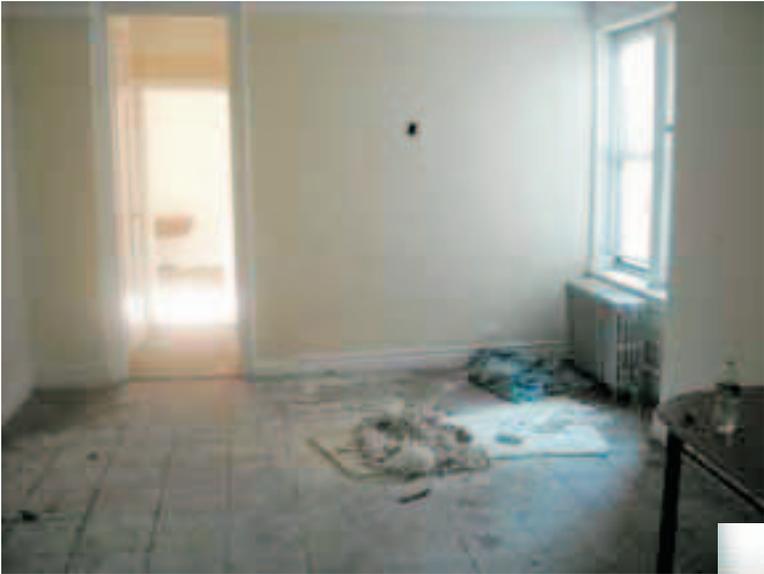
Vacant unit

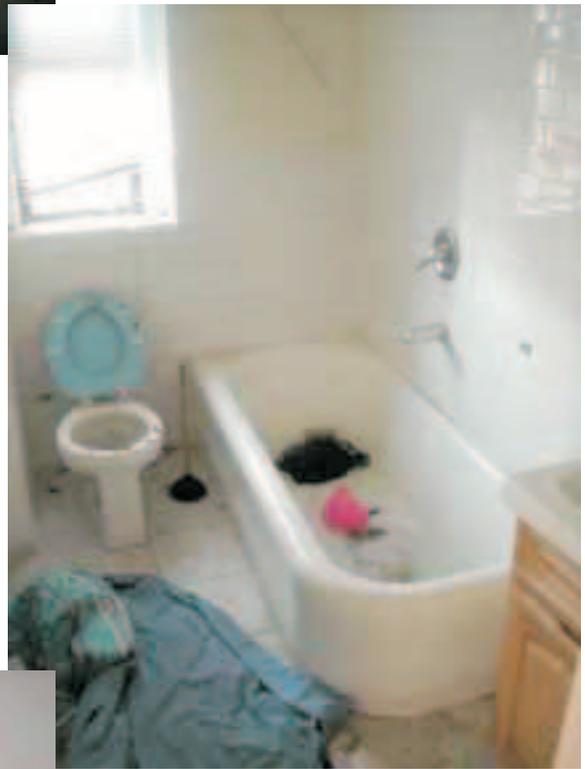
Damaged bathroom of occupied unit

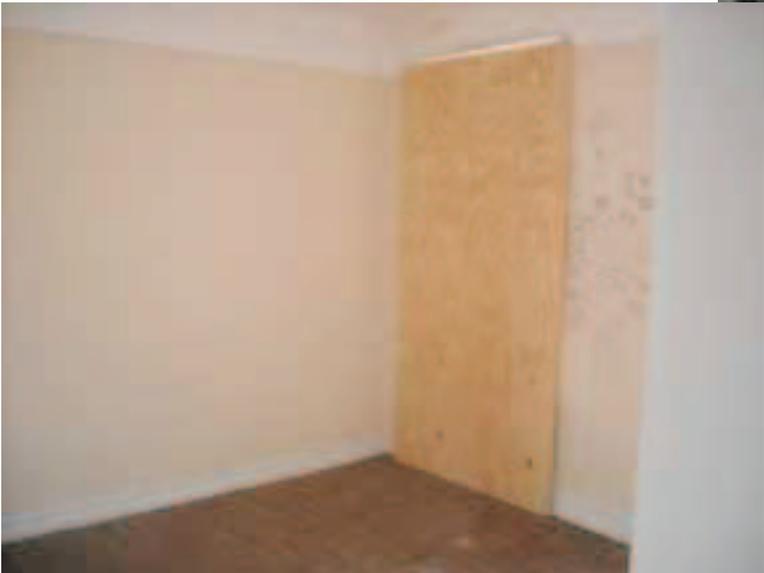
Vacant unit. The plywood is covering an exterior window

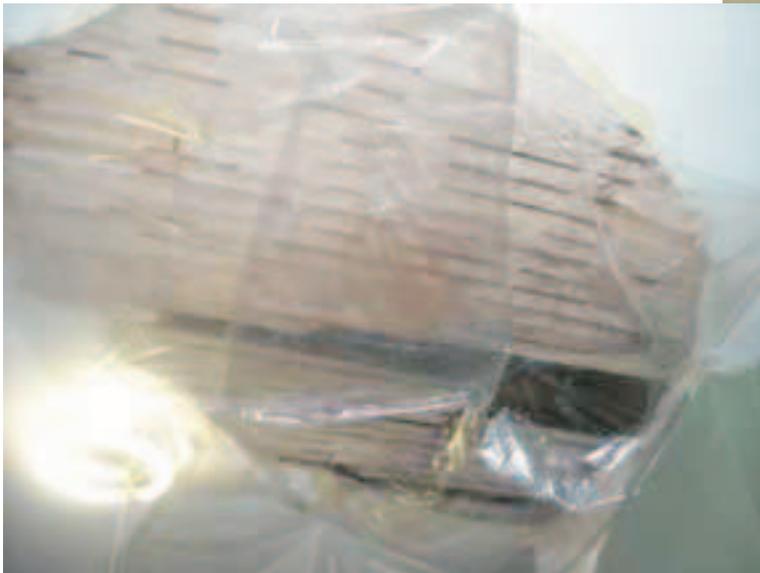
Bathroom ceiling of occupied unit

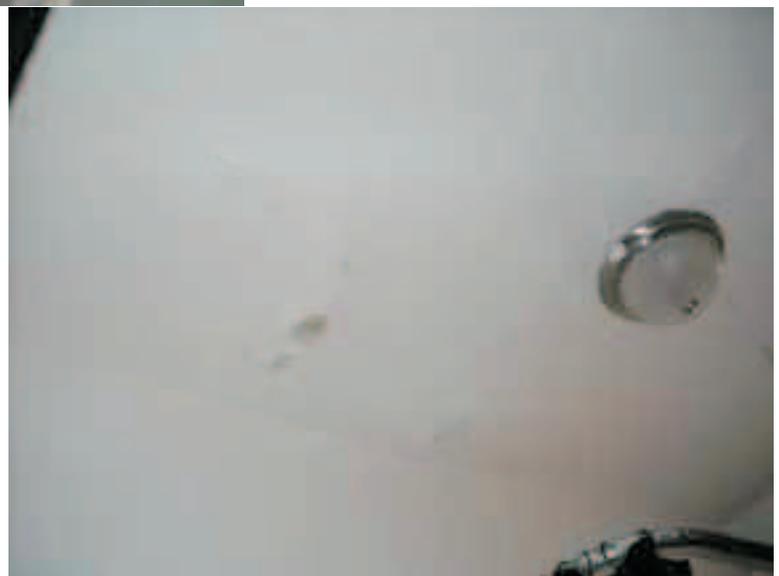
Bathroom ceiling of occupied unit.
