Preliminary Site Investigation Drainage Report

Sunnyside Garden Apartments

51-01 39th Avenue

Project Number: 240818

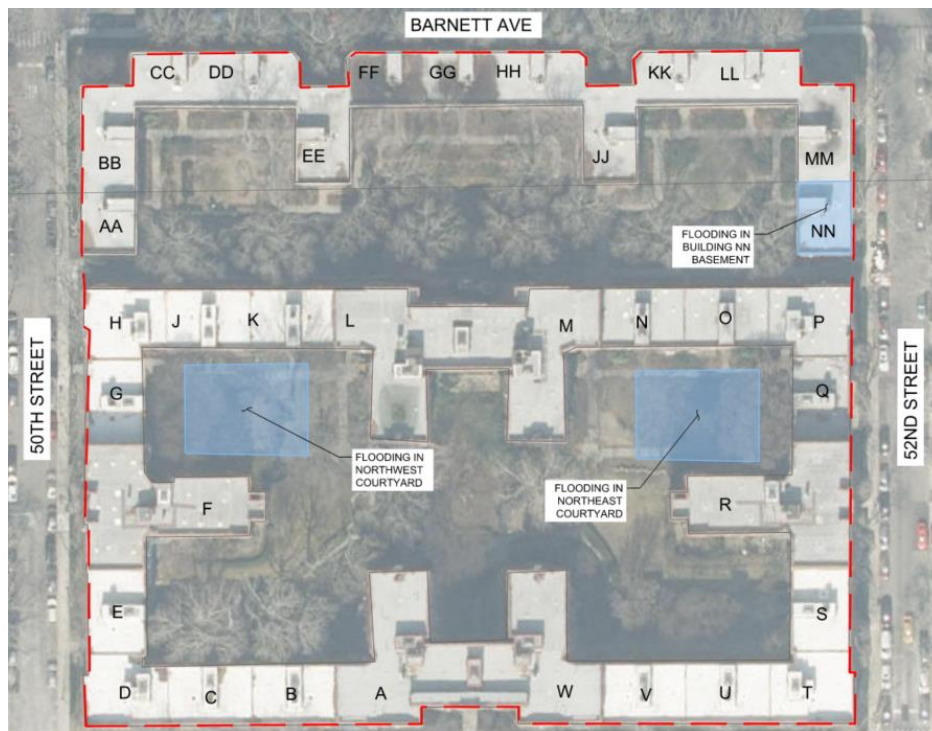
1. Ponding at the northwest courtyard by buildings G through K
2. Ponding at the northeast courtyard by building N through Q
3. Sewer back up in the basement and ground level apartments of buildings JJ through NN

Photo 1 – Building locations and flooding

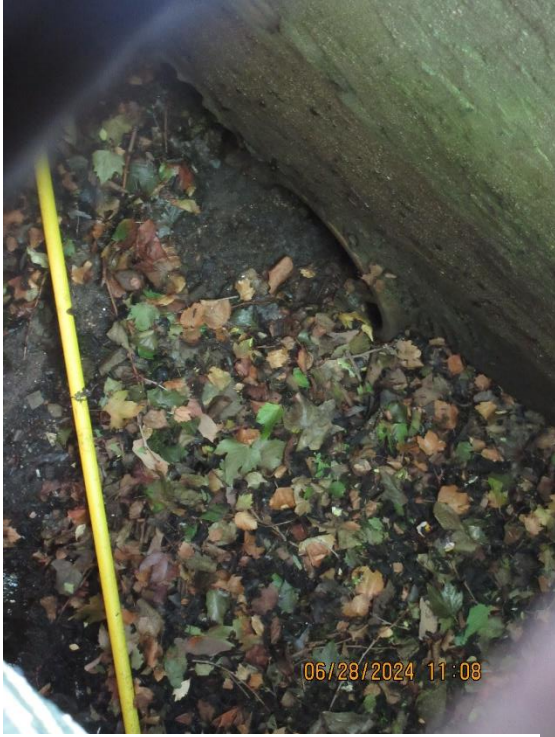
Based on the walkthrough, several of the catch basins are filled with sediment, debris or vegetation, which is impacting stormwater conveyance. Management staff noted that the northwest and northeast courtyards are only impacted during a large downpours t and thereafter the water drains within hours. The records, and corroborated by visual inspection, show the flood prone areas are at the topographically lowest points within the courtyard.

- Runoff may bypass upgradient, sediment-impacted catch basins and collect at the northeast/northwest low-points. It is unlikely these catch basins, or their outlet pipes, were sized for the bypassed flow.
- The storm drainage system flows from north to south, whereas the topography generally slopes from south to north. This means that drainage pipes “buck-grade” and likely have shallow slopes. This was corroborated by observing several very deep drainage structures at the topographically high parts of the site. Shallow sloped pipes are more prone to sediment impacts.

Photo 2 – Debris filled trench drain

- i. Phase 1 – Catch Basin Cleaning
 - a. Clean all existing catch basins and trench drains within the courtyard. Remove accumulated debris, vegetation, soils and sediment within the structures.

- b. Where feasible, clean pipe openings within structures.
 - c. Refer to Appendix B for map identifying the critical catch basins / trench drains to be cleaned out per the site visit.

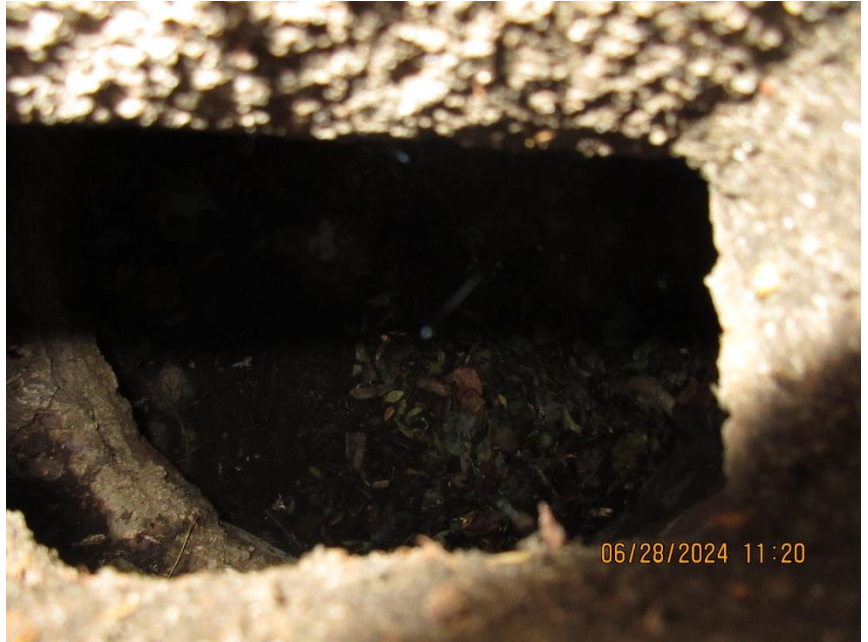
Photo 3 – Debris-filled catch basin in northwest courtyard

- d. On-Going Maintenance: Regularly inspect catch basins following rainfall events. Remove accumulated debris to prevent clogging of outlet pipes, specifically at catch basins located in northeast and northwest sections of courtyard.

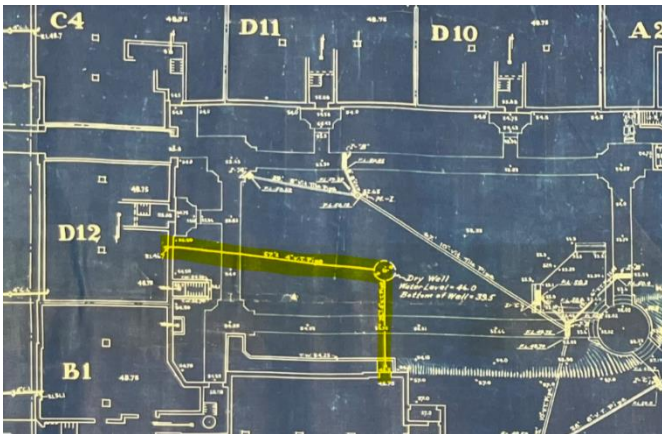
Existing records indicate the presence of two drywells that were not visually verified in during the site visit. The records indicate that the drywells collect stormwater runoff from stairwell drains with small contributing areas and potential sump pits in the building. This information is to be verified through a video inspection. It does not appear these drywells contribute to collecting, retaining, or infiltrating stormwater runoff from the site except for the small stairwells.

Photo 4 – Record drawing with highlighted stormwater connections of the dry-well in northwest

- d. Locate drywells by TV inspecting from stairwell drains to confirm that drywells exist and verify the locations.
 - e. Refer to Appendix C for map identifying the critical truck lines to inspect.

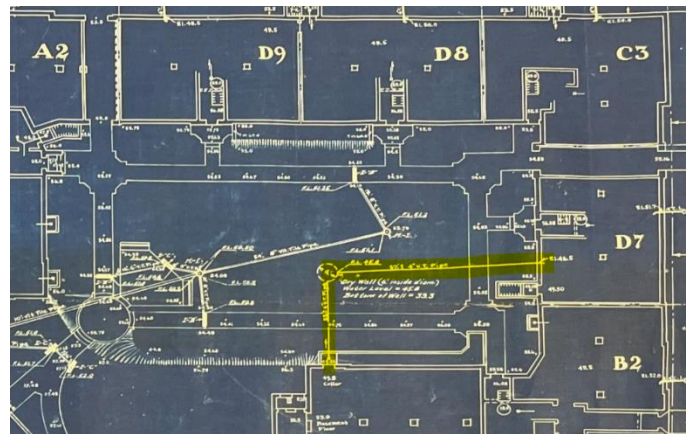
Photo 5 – Record drawing with highlighted stormwater connections of the dry-well in northeast courtyard

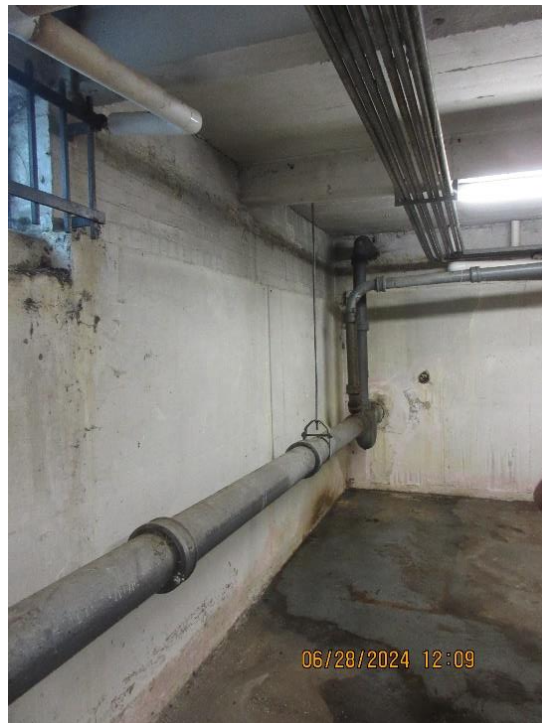
Building management staff reports storm/sewage back up on the ground floor apartments of building at JJ thru NN in the past. It is believed that the flooding impacts of these apartments is the results of toilet/tub/shower back ups as opposed to stormwater runoff from outside of the building. Management staff notes that opening the sanitary house trap in the basement allows the backups to be contained to basement rather than backing up to the ground floor apartments. The reason for back up is not known at this time and requires additional investigation to determine cause, refer to recommendations section.

Photo 6 – Existing house trap located at Building NN

The flooding at ground floor apartments appears to have been rectified by property management opening the cover at the basement house trap during extreme rain events. However, this is a temporary fix. Based on the available records, it is unclear whether the house traps have a direct connection to the 15-inch sewer in the alley or to another sewer connection in 52nd Street. TV inspections may identify additional downstream blockages that could rectify semi-recurring basement flooding without the need to regularly open the basement house trap. It is recommended to hire a plumbing engineer familiar with older buildings to assess and provide recommendations.

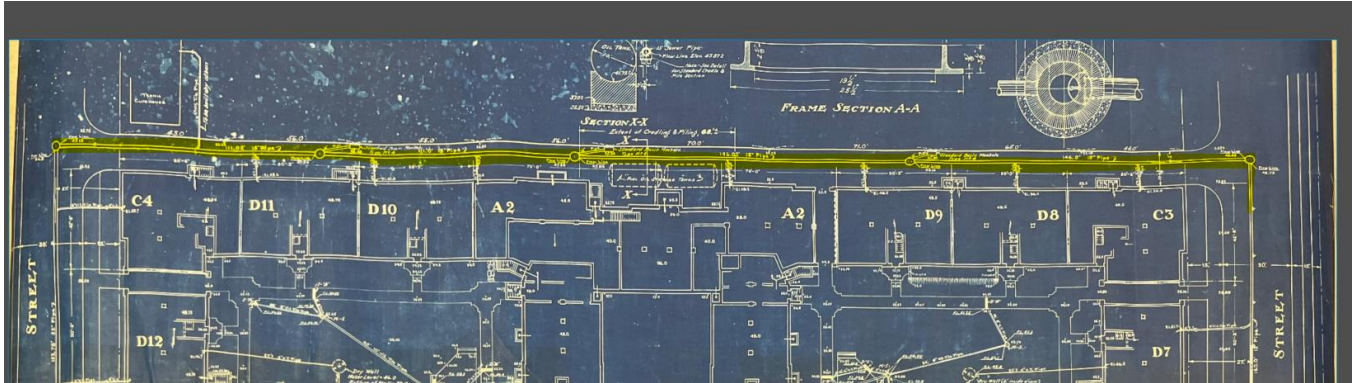
Based on available building records and city public sewer maps, there is a 15 to 18 inch sewer line running along an alley that separates the southern apartments (A-W) and courtyards with the northern apartments (AA to NN). As described above, it's unlikely that capacity issues with city infrastructure are causing the ponding impacts at the courtyard. However, City sewer infrastructure might be causing backups at buildings JJ thru NN. Additional investigations are needed to confirm.

Photo 7 – Record drawing with highlighted sewer line running along the alley that separates the southern apartments and courtyard with the northern apartments
