uhab | urban
homesteading
assistance
board

milbank building portfolio needs assessment report

2010 september 21

**Milbank Housing
Portfolio**

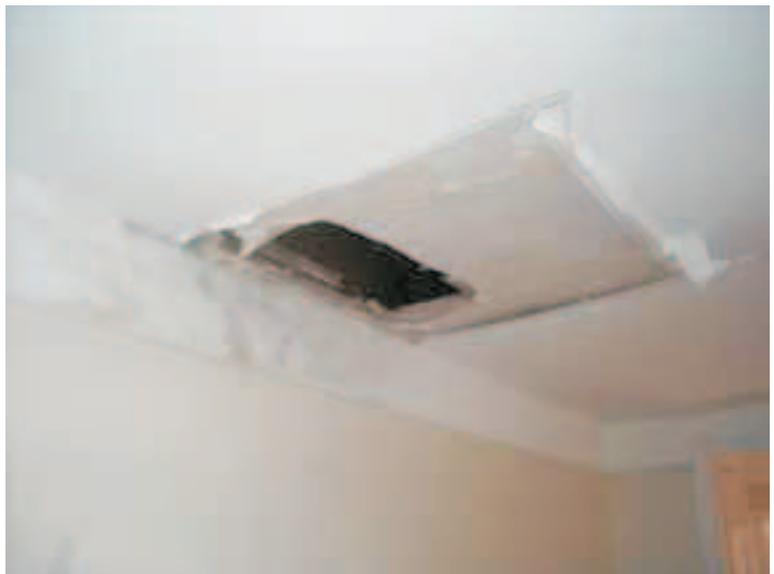
Damaged living room ceiling from
water infiltration

Recommendation: Repair floors, walls and ceilings as required per unit. Prepare units to receive new paint throughout. Remediate mold locations.

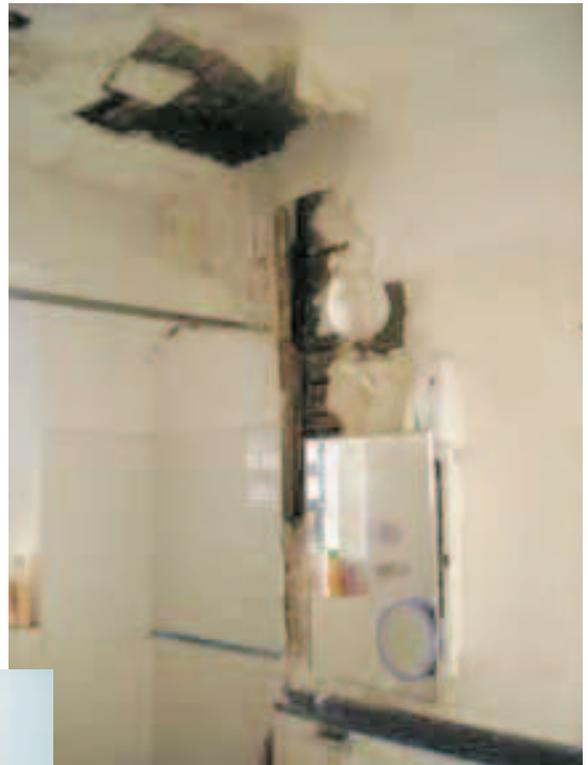
Bathroom of occupied unit.
