Preliminary Site Investigation Drainage Report

Sunnyside Garden Apartments

51-01 39th Avenue

Project Number: 240818

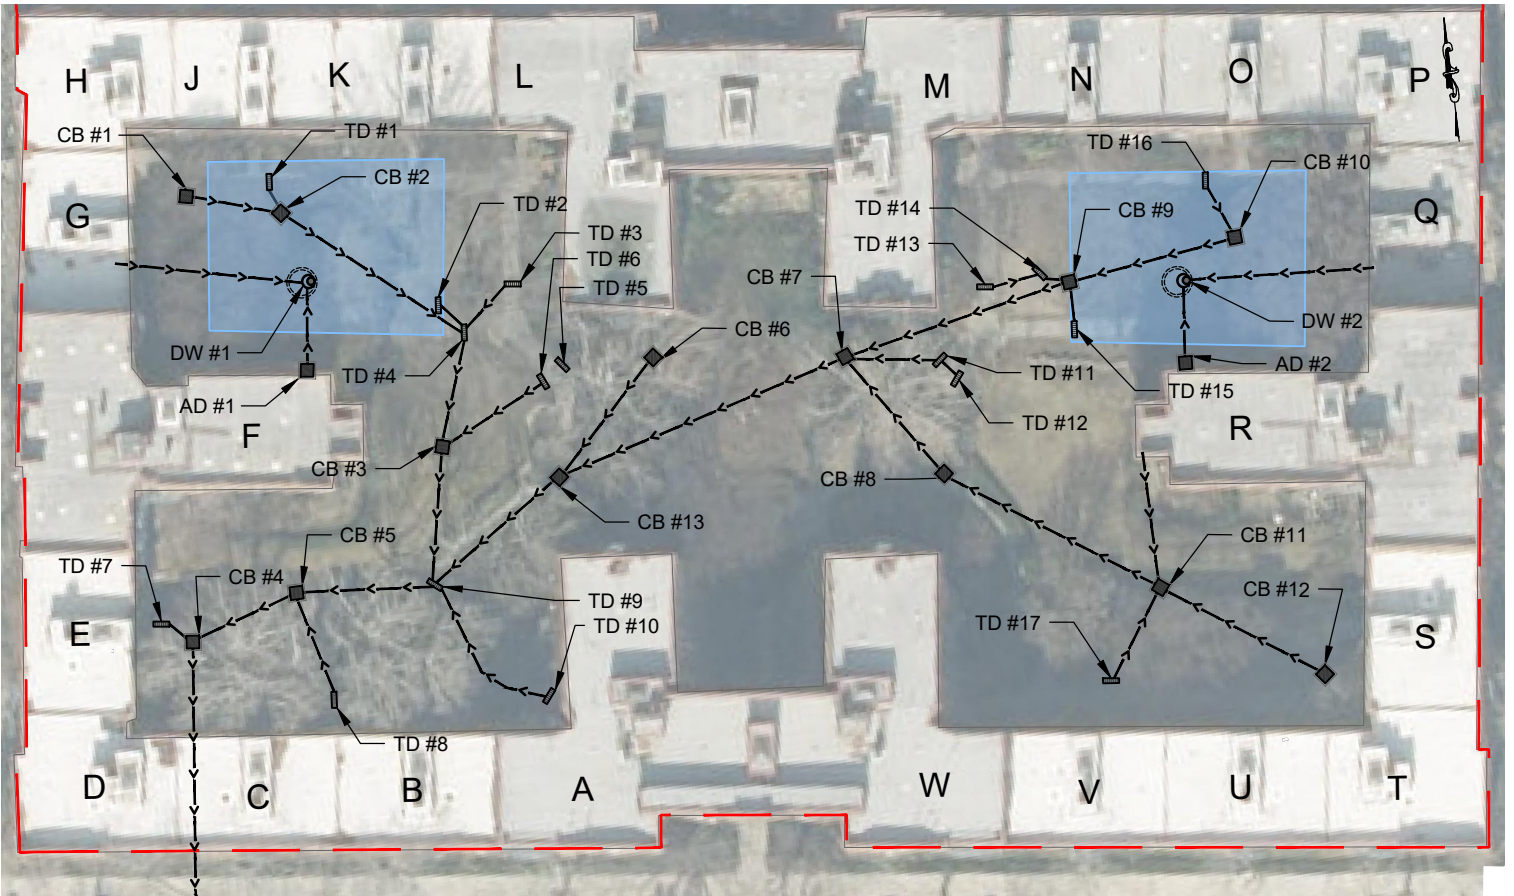
COURTYARD MAP

Based on the walkthrough, several of the catch basins are filled with sediment, debris or vegetation, which is impacting stormwater conveyance. Management staff noted that the northwest and northeast courtyards are only impacted during a large downpours t and thereafter the water drains within hours. The records, and corroborated by visual inspection, show the flood prone areas are at the topographically lowest points within the courtyard.

- Runoff may bypass upgradient, sediment-impacted catch basins and collect at the northeast/northwest low-points. It is unlikely these catch basins, or their outlet pipes, were sized for the bypassed flow.
- The storm drainage system flows from north to south, whereas the topography generally slopes from south to north. This means that drainage pipes “buck-grade” and likely have shallow slopes. This was corroborated by observing several very deep drainage structures at the topographically high parts of the site. Shallow sloped pipes are more prone to sediment impacts.

Based on the site investigation, it is possible that courtyard ponding is a result of non-functioning drainage infrastructure. AKRF recommends a phased approach to further analyze and potentially rectify the drainage issues.

- ii. Phase 2 – Pipe TV Inspection & Cleaning
 - a. TV inspect all pipes along the trunk line from low points to outlet under Building D to identify potential sedimentation, damages, blockages, tree root intrusions, etc.

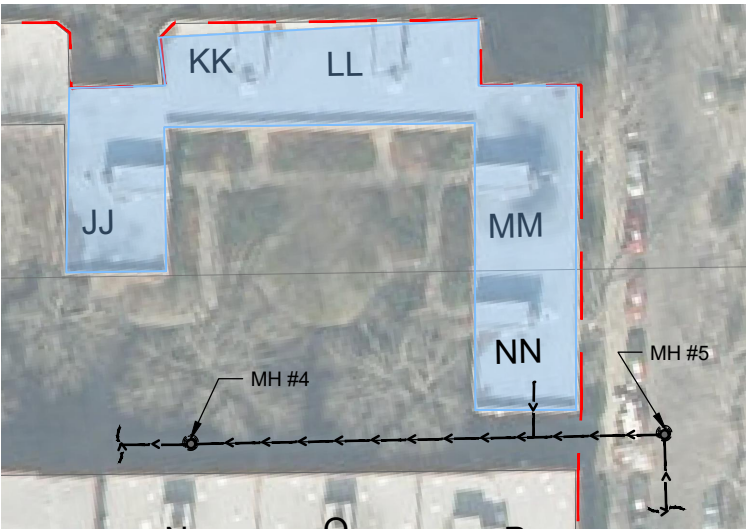
BUILDINGS JJ-NN MAP

Buildings JJ through NN are located in the northeast corner of site north adjacent to 52nd Street. The sanitary flow and building roofs are believed to combine inside the cellar of building NN and connect to sanitary laterals. Figure 1 below shows the building laterals based on the Record Sketches found in Appendix D. Connection point for the sanitary laterals that go from the sanitary trap to the city sewer is not known.

Building management staff reports storm/sewage back up on the ground floor apartments of building at JJ thru NN in the past. It is believed that the flooding impacts of these apartments is the results of toilet/tub/shower back ups as opposed to stormwater runoff from outside of the building. Management staff notes that opening the sanitary house trap in the basement allows the backups to be contained to basement rather than backing up to the ground floor apartments. The reason for back up is not known at this time and requires additional investigation to determine cause, refer to recommendations section.

The flooding at ground floor apartments appears to have been rectified by property management opening the cover at the basement house trap during extreme rain events. However, this is a temporary fix. Based on the available records, it is unclear whether the house traps have a direct connection to the 15-inch sewer in the alley or to another sewer connection in 52nd Street. TV inspections may identify additional downstream blockages that could rectify semi-recurring basement flooding without the need to regularly open the basement house trap. It is recommended to hire a plumbing engineer familiar with older buildings to assess and provide recommendations.
